PHOTOGRAPHIC INTERPRETATION REPORT

SARY-SHAGAN
R&D RADAR FACILITY 2
USSR

TCS-80608/67

SEPTEMBER 1967

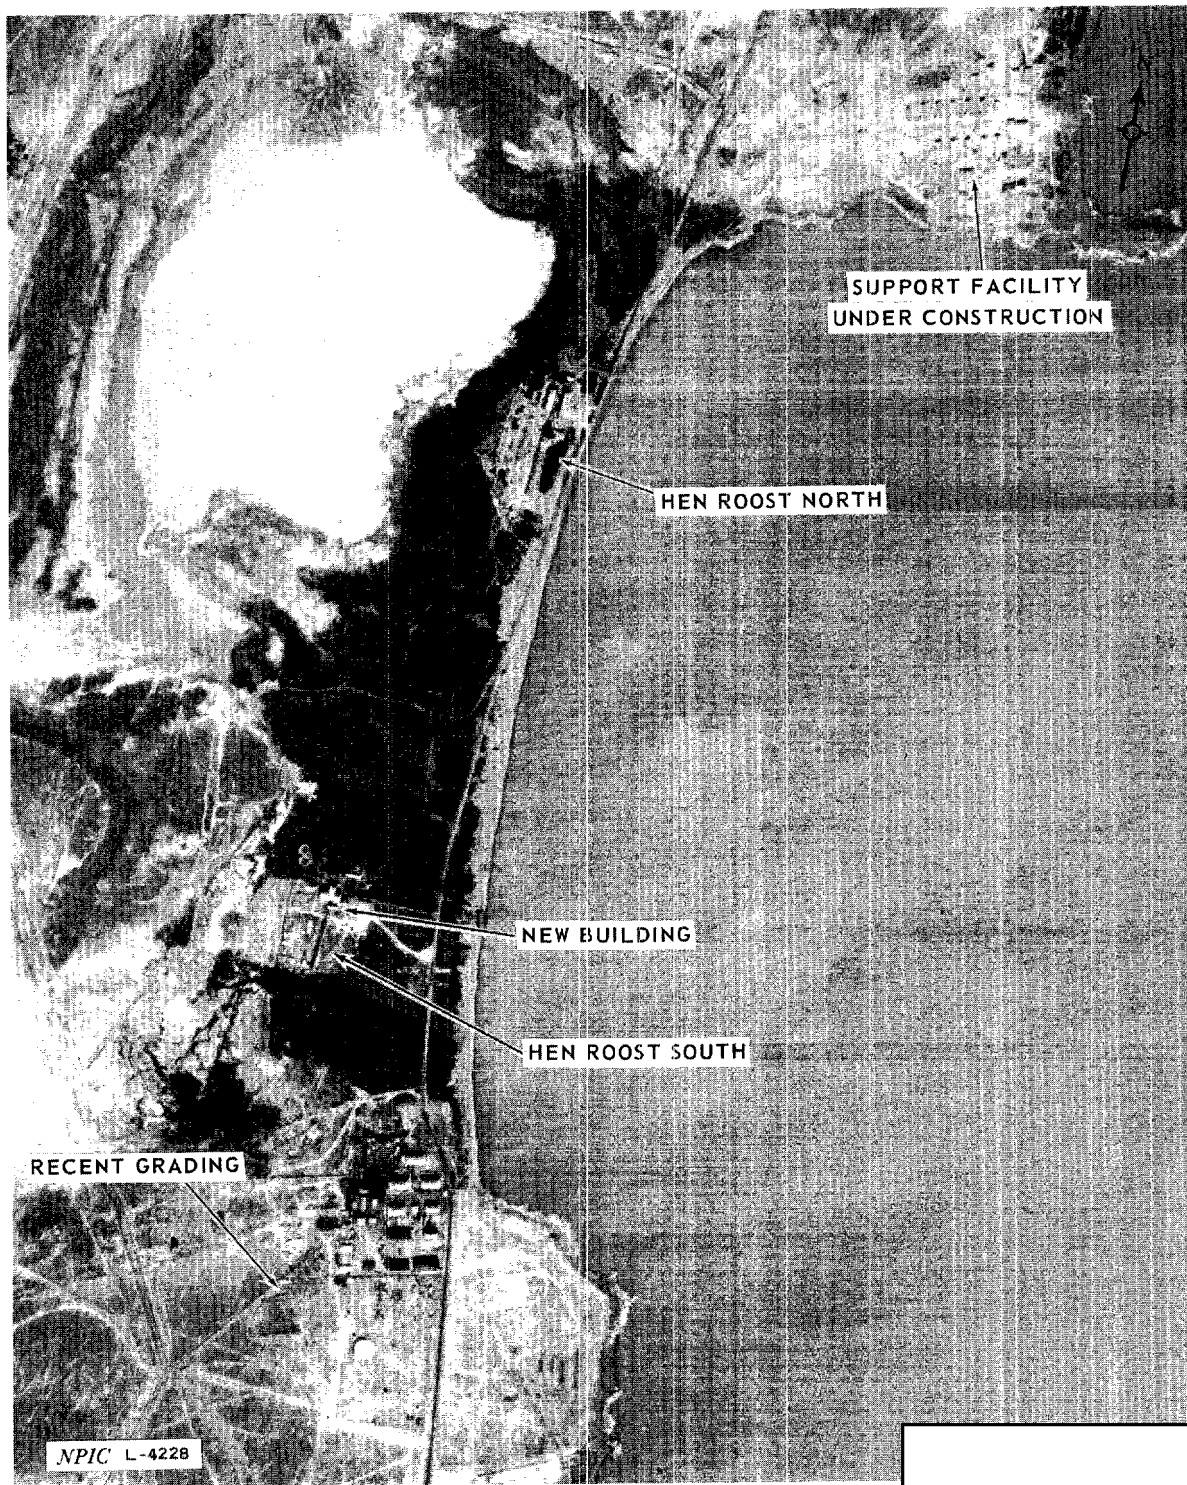
Considerable progress is noted since [REDACTED] in a secured support facility under construction approximately 3,000 feet northeast of HEN ROOST Antenna North. The facility consists of 23 buildings, largely housing type, in various stages of construction. The facility buildings and service road can be negated on [REDACTED]. First evidence of road and building construction was noted on [REDACTED].

Construction status of antennas at HEN ROOST NORTH and HEN ROOST SOUTH is undetermined on this mission. At HEN ROOST SOUTH a small building has been erected since [REDACTED] between the control building and the antenna. The number of crates has increased during this period just west of the antenna. Identification only is possible on the 3 suspect antennas south of the Support Area. A generally rectangular area of grading, approximately 375 by 295 feet, new since [REDACTED] and under work since [REDACTED] is observed just west of these suspect antennas.
